Leadwood Mine Tailings Impoundment

Inspection of Leadwood Dam Decant Structure

***Prepared for
The Doe Run Company***

October 2013

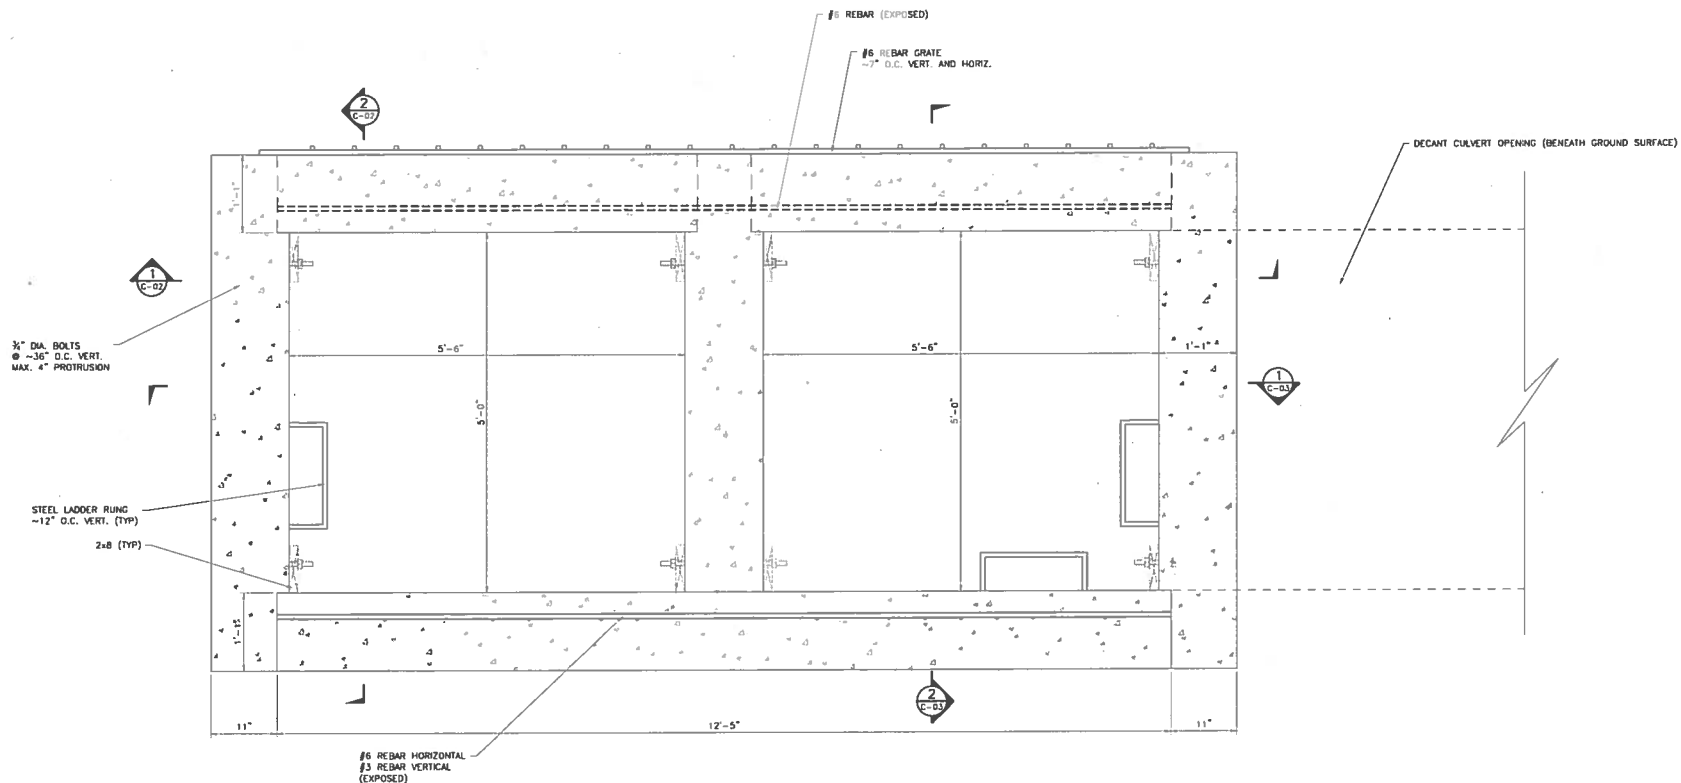
1 PLAN: DECANT TOWER
 SCALE IN FEET

Figures C-02 and C-03 show specific locations where seepage was occurring and gives an overview of the more relevant areas of tower damage. Sections 2.1.2 and 2.1.3 below give overviews of specific observations in the tower shafts.

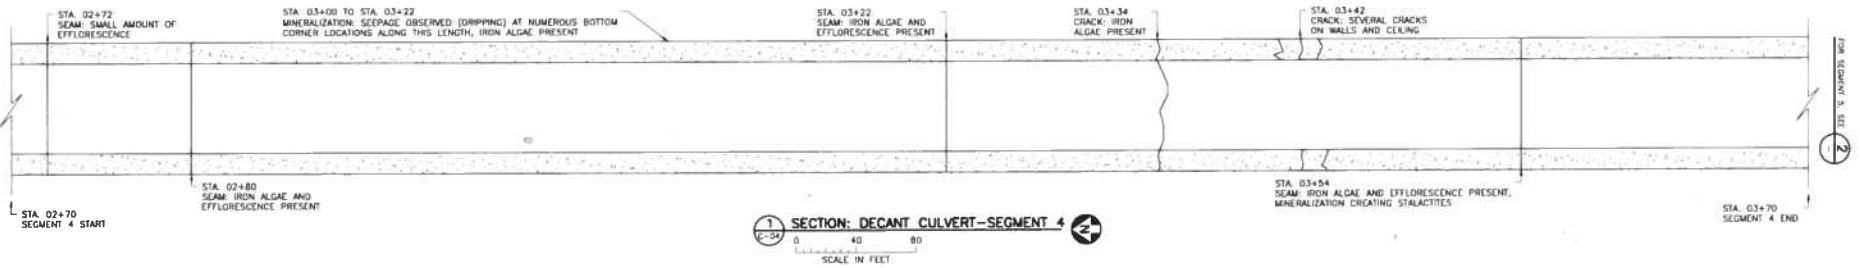
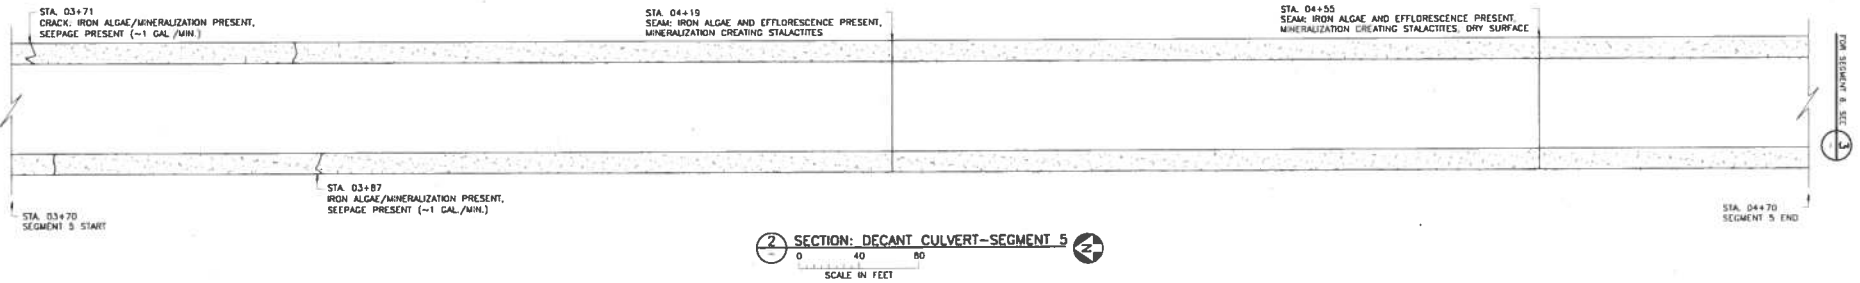
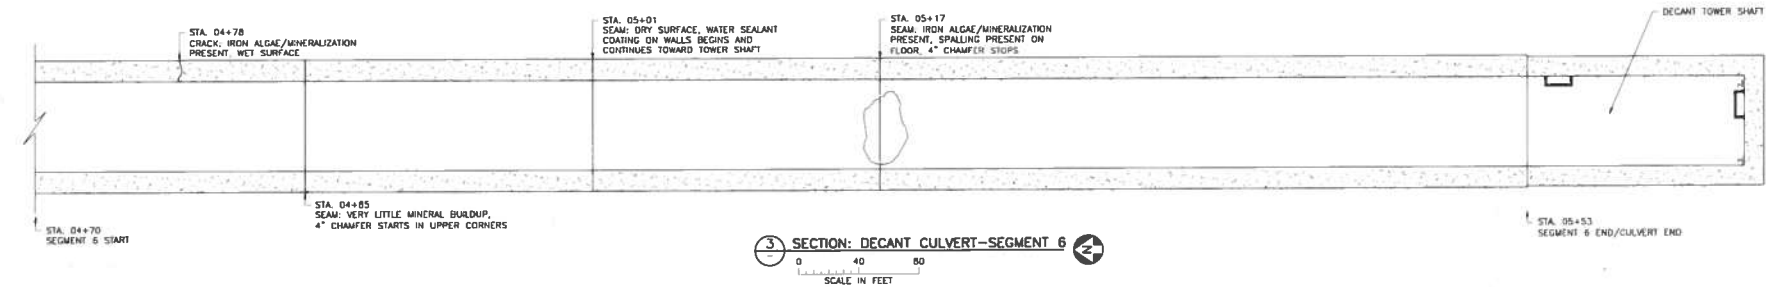
There were several minor cracks along the length of the culvert. There were also two locations where the seams of two sections of the culvert were misaligned. These were at 192 feet in from the culvert discharge and 199 feet in from the culvert discharge.
